# AUSTIN, LEWIS & ROGERS, P.A.

- RE: • Duke Energy Carolinas, LLC ("Duke Energy Carolinas") Annual Review of Base Rates for Fuel Costs.  
• Docket Number 2006-3-E.  
• **Filing of Materials Related to Catawba Outage.**

Duke Energy Carolinas' Significant Event Investigation Team- Final Report of August 4, 2006.

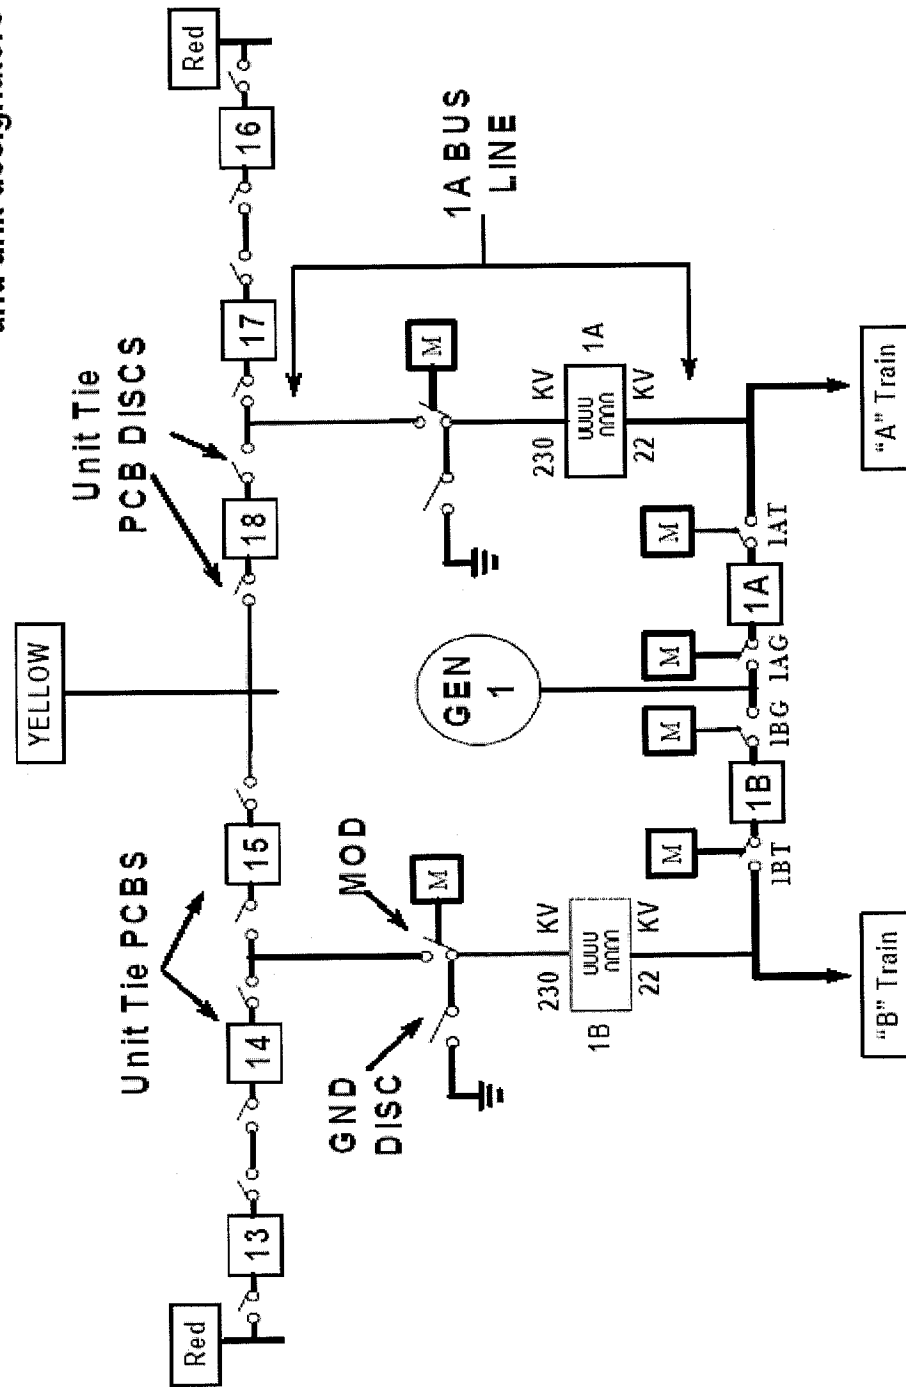
## 230/22 KV System

With both units at 100% power, all of the breakers shown in the simplified diagram above are in the CLOSED position.
